**INTERNSHIP REPORT AT PT. MITSUBISHI ELECTRIC
AUTOMOTIVE INDONESIA, BEKASI, INDONESIA**

**By
Muhammad Arif
ID No. 004201100023**

This project is done to minimize the NG existence at PT. MEAINA especially the bracket flowing to machining process. The elimination of NG existence is done through Plan, Do, Check, Act (PDCA) method. NG existence has become one of the main problems. Generally, NG can be categorized into two categories, NG caused by supplier and NG caused by machining process. 36.8% of total NG is caused by machining process and 63.2% of total NG caused by suppliers. Then, the most defective line found is Starter Bracket Front line. The most type of NG caused by supplier is small diameter lever which contribute 3,711 pieces and shown as the highest. Based on the analysis, the small diameter lever is mainly caused by the wrong inspection method and no supporting tools. Thus, diameter lever area is added to the inspection check sheet and the new jig is used to check the diameter lever area. This treatment result in 0% defect of diameter lever area and save cost up to IDR 218,970,000.

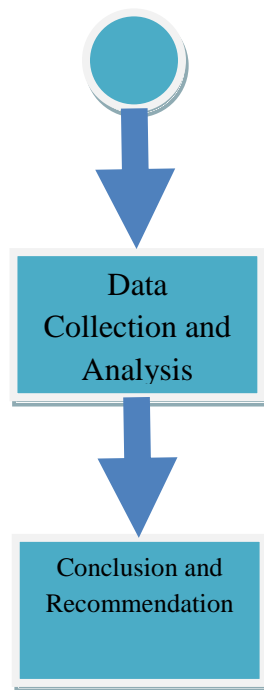
This Chapter informs the reader how the project was conducted by describing the detail steps in conducting the research. The steps should be set systematically to help the researcher solve the initial problems. By constructing the suitable research methodology, the research and analysis can be done accurately. Hereby the steps performed to solve the initial problems in this research as follow:

Data Collection and Analysis

- To explain the current condition of PT. MEAINA
- To obtain the data of highest type of NG existed
- To obtain the data of the most defective lines
- To obtain the main cause of the problem

Conclusion and Recommendation

- To make a conclusion which answer the research questions.
- To give recommendations for the company and for future purposes.

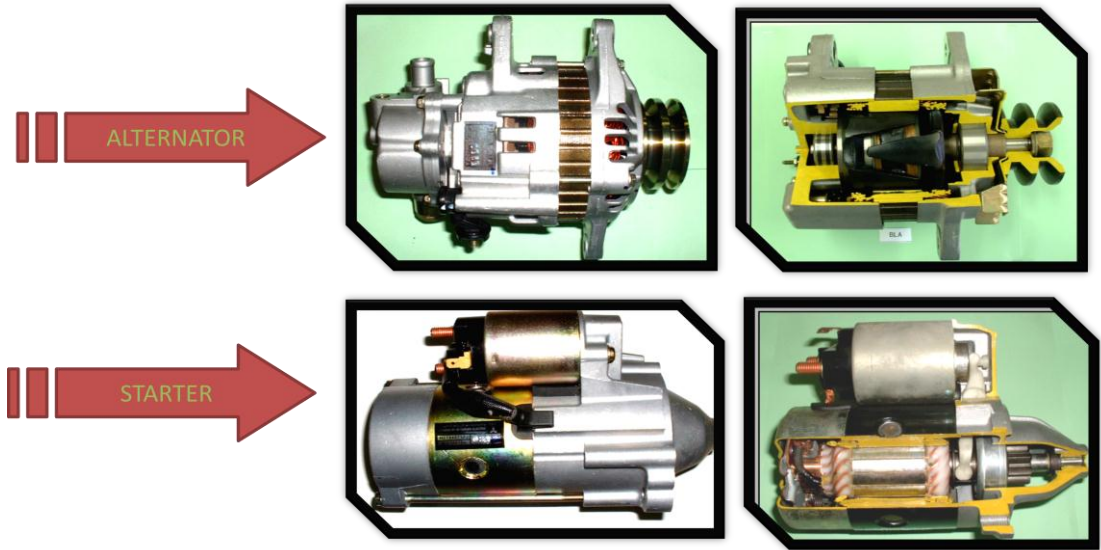
Figure 4.4 Assembly Product of PT. MEAINA

Above is the assembly product produced by PT. Mitsubishi Electric Automotive Indonesia. There are two assembly lines at PT. Mitsubishi Electric Automotive Indonesia; Starter assy and Alternator assy. Rotor is used as the source of electricity

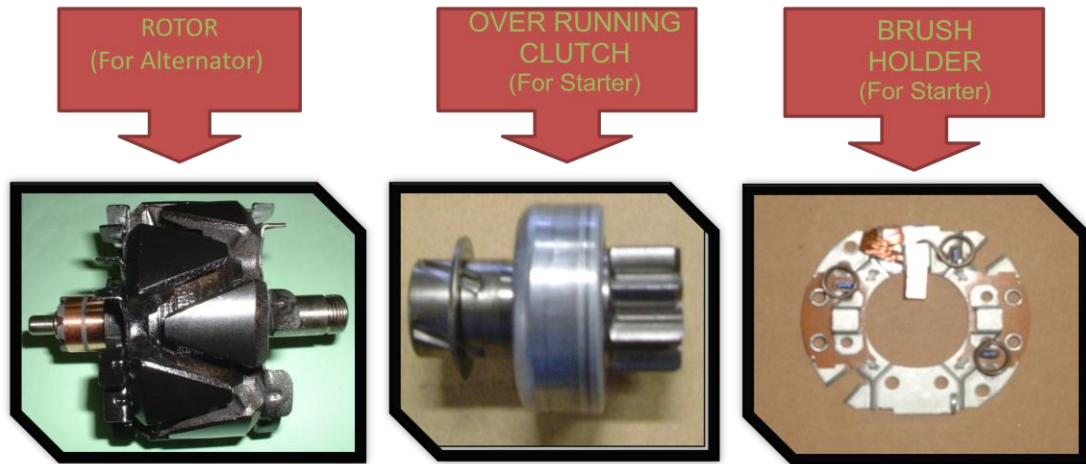
Figure 4.5 Part Manufacture Product of MEAINA

Above is the parts manufacture produced by PT. Mitsubishi Electric Automotive Indonesia consisting of Rotor for alternator, over running clutch for starter, and brush holder for starter.

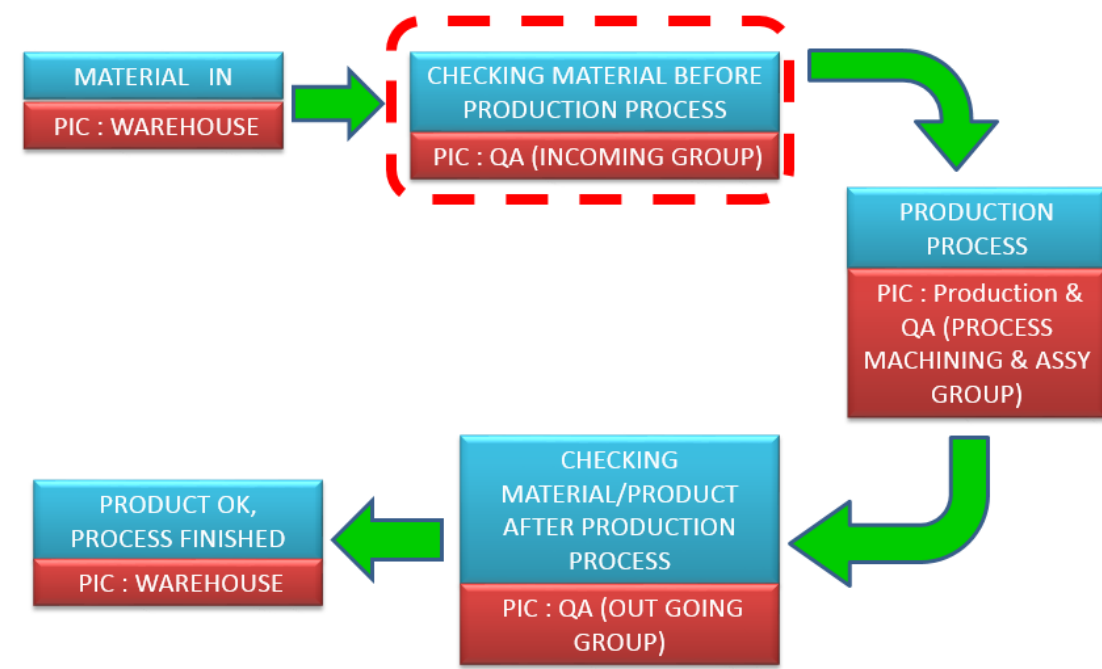
Figure 5.1 Flow Process of Daily Production

The figure above shows flow process of daily production at PT. Mitsubishi Electric Automotive Indonesia (MEAINA). Since the topic of this study is to prevent the flow of defective bracket at incoming area to machining process, then the analysis must be began from the very first time blank bracket arrive to PT. Mitsubishi Electric Automotive Indonesia until those blank brackets are machined. As this study focuses on the NG blank bracket caused by supplier and have been the concern of quality incoming section, the area of study will only the stuffs that involve quality incoming section and anything related with it to analyze the NG caused by supplier.

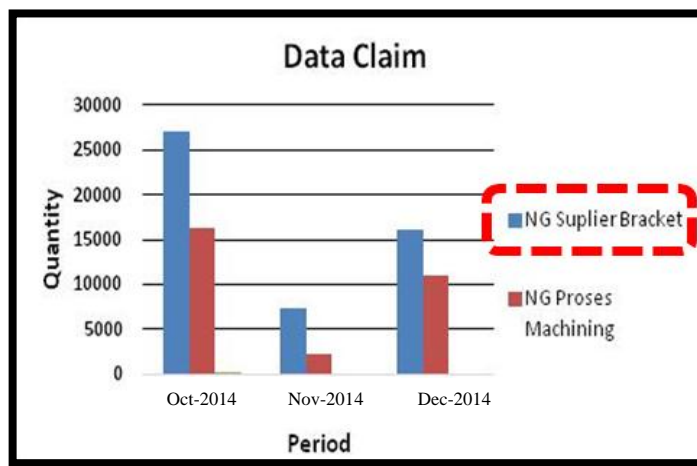
Figure 5.2 Data Claim Report at the End Of 2014

At first, the monitoring process is done through figuring out which NG is more dominant, whether it is NG caused by supplier or NG caused by machining process of PT. Mitsubishi Electric Automotive Indonesia. The data collection is done for the NG data at the end of 2014 because for that period, the Scrap Production Report (SPR) has been closed so the data can be easily utilized.

Looking at the data, there are fluctuations of amount of NG for NG caused by supplier. For three last month at the end of 2014, October shows the highest rate of NG, then significantly decrease on November and increase again on December. The pattern happens at NG data caused by machining process. But, the increasing and decreasing are not really significant as shown at the table and figure.

Looking at the data again, it is clearly proved that the NG caused by supplier is way bigger than the NG caused by machining process of MEAINA. The total NG caused by supplier for last three months of 2014 is 50,488 pieces and it is only 29,504 pieces of defective bracket caused by machining process. The difference of 20,984 pieces shows a very significant difference for those two kinds of NG. Thus, that is why the focus of this project is to minimize NG caused by supplier as it gives the biggest impact and it causes the biggest loss.

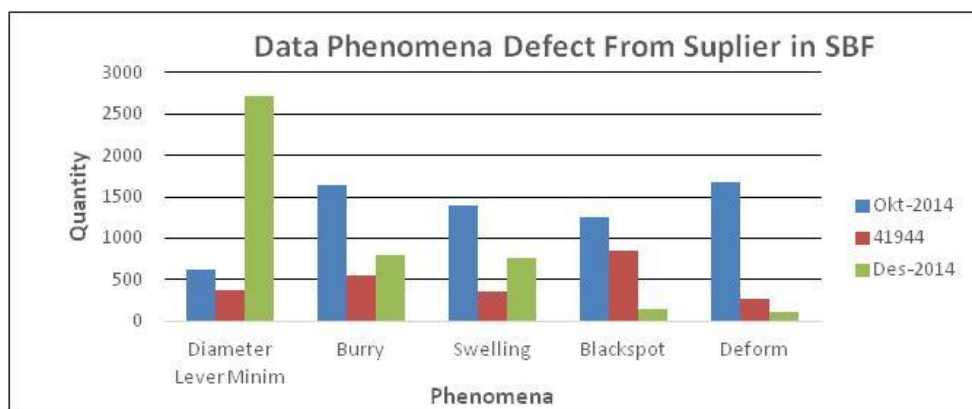
Figure 5.4 Data Phenomena Defect From Supplier at Line SBF

After getting the information whether the NGs are mostly caused by suppliers or caused by process at PT. Mitsubishi Electric Indonesia and based on the data it is proved that NGs caused by supplier are much bigger in comparison with NG caused

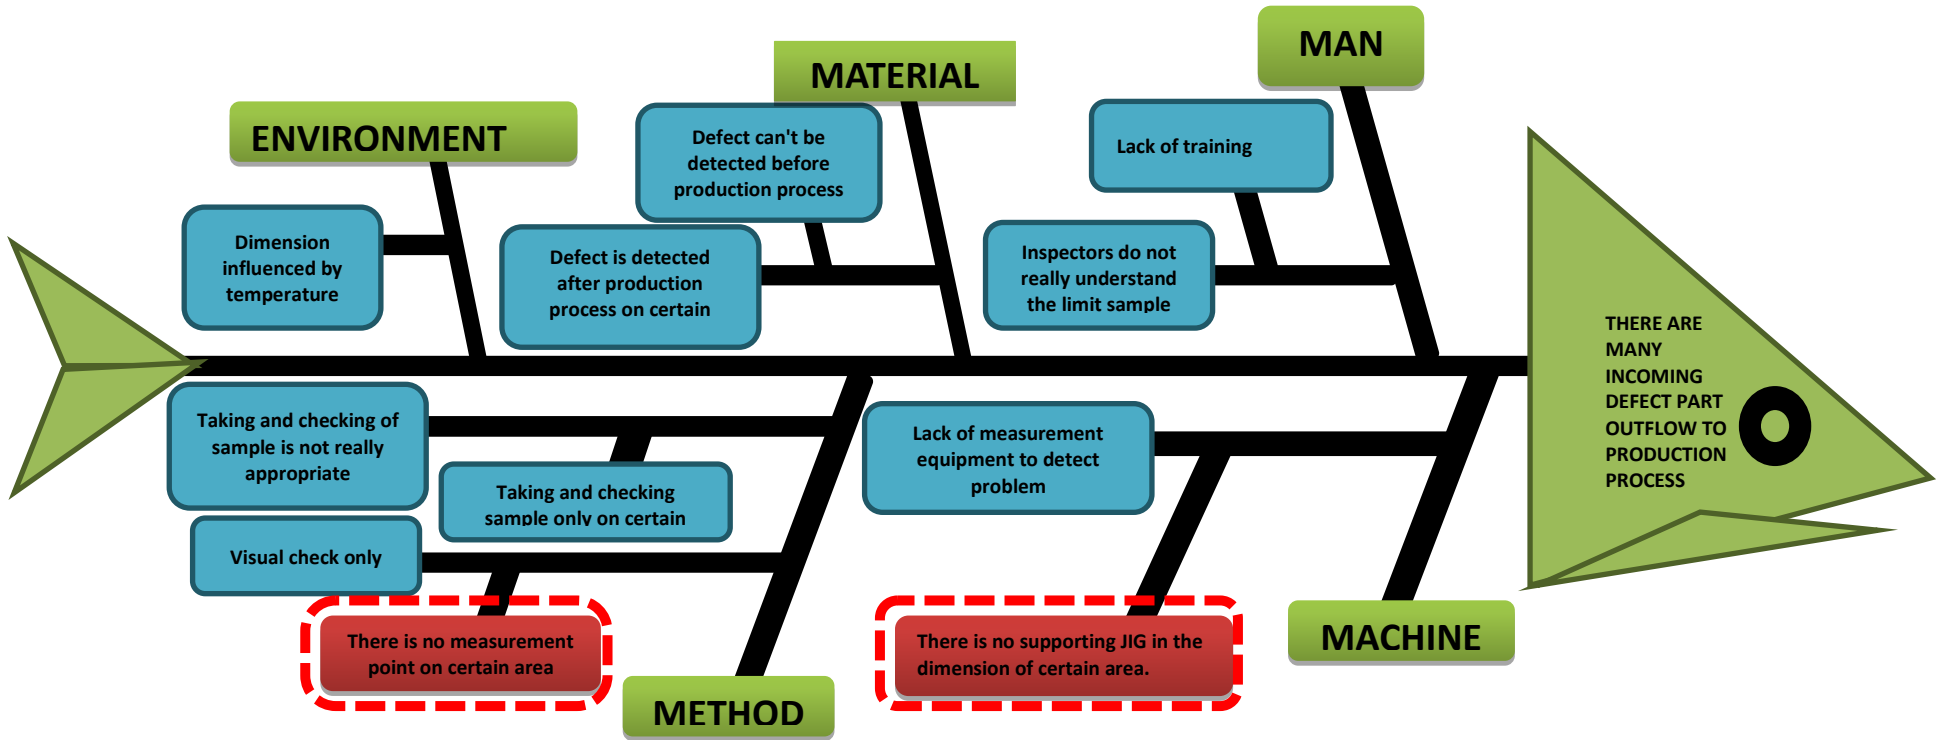
Figure 5.5 Fish Bone Diagram

Figure above shows the fishbone diagram involving the 4M + 1E analysis; Man, Machine, Material, Method, and Environment. This tool is part of Quality Control 7 tools and usually uses to analyze the effect of one main cause as being done through this project. The analysis to find the root cause of this problem is done through analyzing those five important aspects. Machine, material, method, and environment have played an important role on this project. The purpose of this fishbone diagram is actually only to see and analyze how far those suspected factors on this cause and then will be analyzed and the effect of each factors to this main cause of incoming defects that flows to machining process.

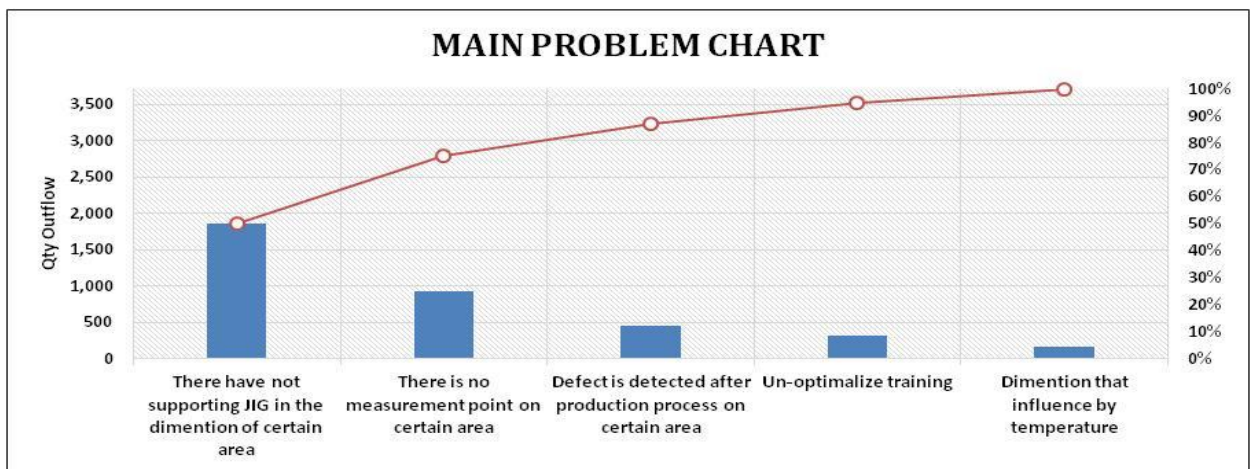
Figure 5.6 Main Problem Chart

by temperature. The cumulative of the NG is 100% meaning that the whole tested NG bracket are inspected and the cause of NG is analyzed and judged. This is the NG bracket that are machined by Starter Bracket Front line as found as the most defective line through the execution of this project. After finding the dominant cause the main problem, so the next focus of this project is to improve and minimize the NG bracket at diameter lever area through providing dimension jig on certain area and add the measurement point on certain area, in this case it refers to the diameter lever area.

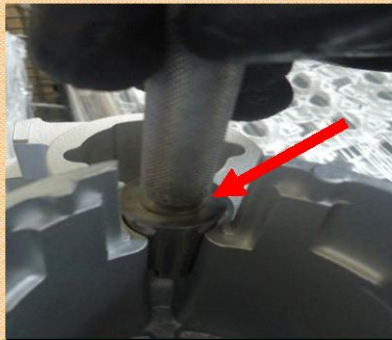
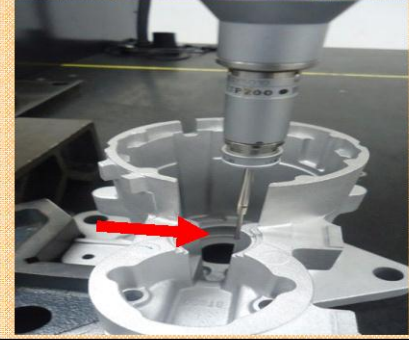
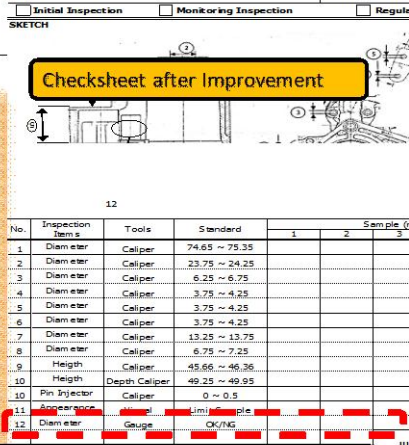
Check by Gauge

Check By CMM

Checksheets after Improvement

Condition after improvement there are Inspector QC Incoming Checking by using visual check, Pin Gauge based on Check sheet at Diameter Lever position & verification by CMM

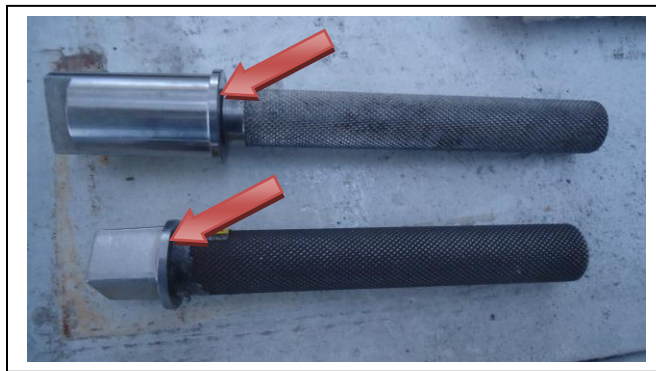
Figure 5.11 Picture of the Gauge Used

Above is the specification of the gauge used to check the diameter lever area. By using this gauge that is matched with the specification of the drawing, it is expected that diameter area of bracket that pass through machining process will always be suitable with the specification stated on the drawing.

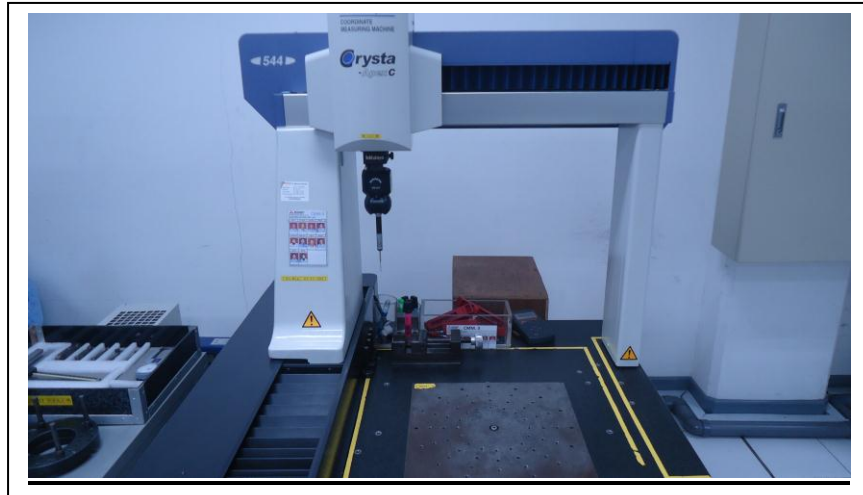
Figure 5.12 Picture of Coordinate Measuring Machine (CMM)

The next process is verification using Coordinate Measuring Machine (CMM). The purpose of verifying the diameter lever using Central Measuring Machine (CMM) is to ensure the diameter of lever area is match with the specification because sometimes, the abnormality can happen. When the abnormality on diameter lever happen, the inspector will directly bring the bracket to measurement room for verification using Coordinate Measuring Machine (CMM).

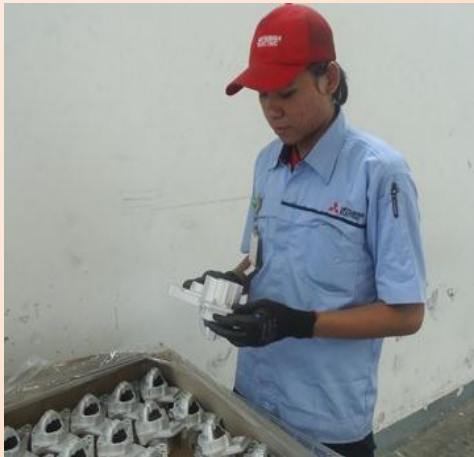
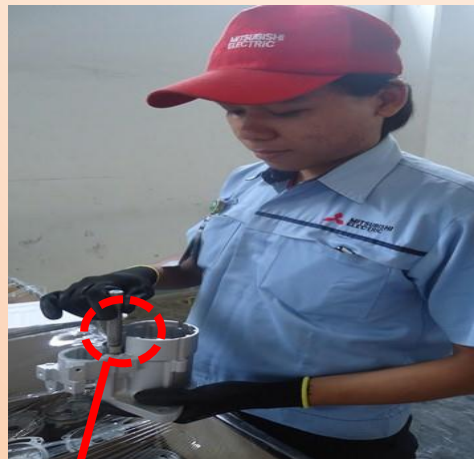
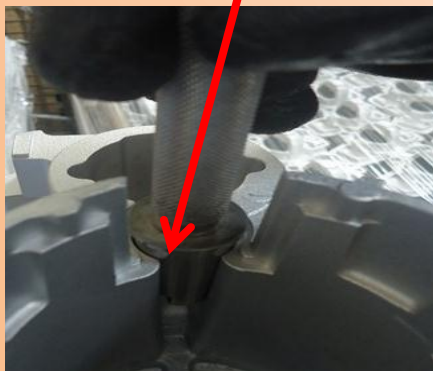
Figure 5.12 New Inspection Process after Improvement

1 Inspector Checking by Visual for appearance on all position

2 Inspector Checking by Pin Gauge at Diameter Lever area.

3 Write the result of checking Diameter Lever on new check sheet (OK / NG)

Detail Point Checking

Position checking by Pin Gauge

The last is improving the check sheet. Since the point for diameter lever has not yet been put on the check sheet, so the improved check sheet must provide this point. The effect of this is to ensure that when the inspectors do the inspection, they must inspect and ensure this diameter lever point also before letting the blank bracket pass through to the machining process.

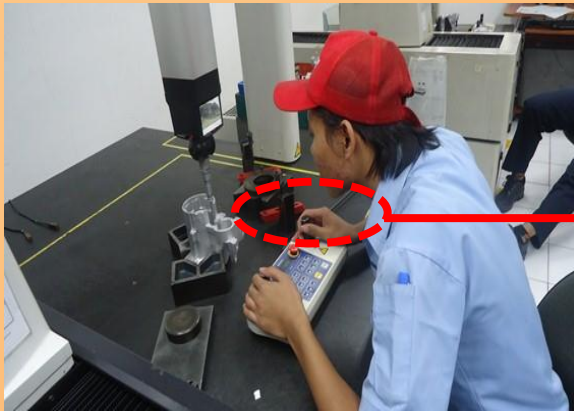
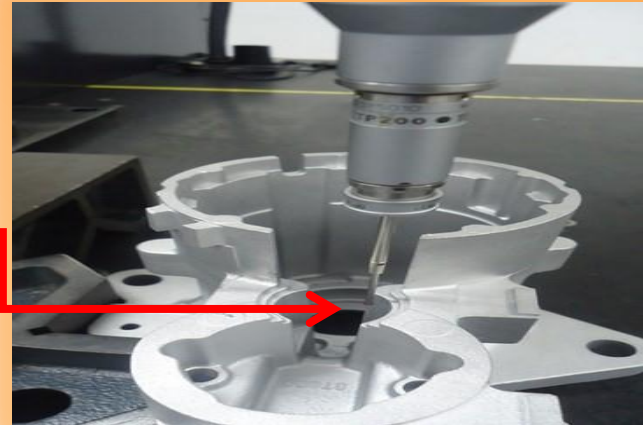
Inspector Measuring By CMM at Diameter Lever area for verification when found abnormality condition.

Position measurement by CMM

X=	316.201	$\alpha =$	90:00:00	$\phi =$	21.070
Y=	288.338	$\beta =$	90:00:00	d=	0.1149
Z=	233.185	$\gamma =$	0:00:00	n=	10
X=	316.118	$\alpha =$	90:00:00	$\phi =$	20.566
Y=	288.316	$\beta =$	90:00:00	d=	0.2933
Z=	219.463	$\gamma =$	0:00:00	n=	10
X=	322.252			d=	0.0000
Y=	294.911			n=	1
Z=	206.600				
X=	316.118	$\alpha =$	90:00:00	$\phi =$	20.403

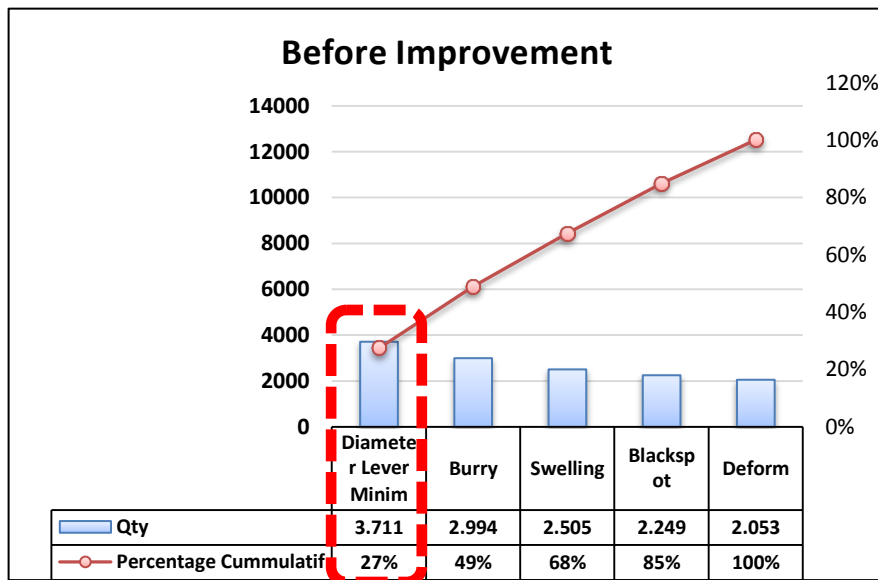
Figure 5.14 Pareto Chat of NG Quantity before Improvement

The before improvement data shows that small diameter lever is the highest type of NG that exist and flow to machining process with the contribution of 27% of total NG of blank bracket. After improvement, it is shown clearly on the data that the improvement has been successfully done. The after improvement data shows that the small diameter lever can be overcome. From contributing 27% of defect, the after improvement data state that the small diameter lever contribute “0” pcs or 0%. It changes from the highest percentage of NG to the lowest percentage of NG.

Above is the Pareto diagram of the condition before improvement and condition after improvement. Small diameter lever initially appears as the highest, then after improvement process, small diameter lever suddenly does not appear anymore, or it can be said as zero diameter lever defects.

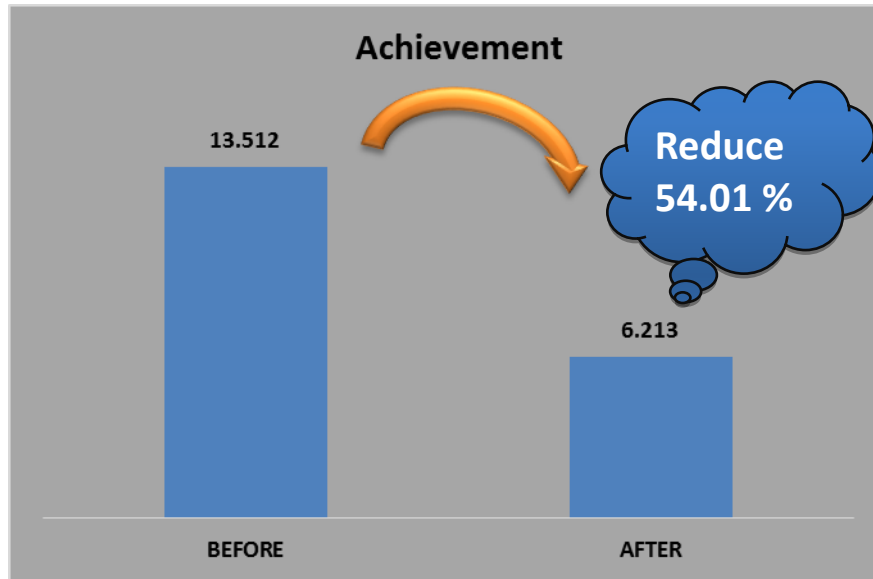
Figure 5.16 Comparison of NG Quantity before and after Improvement

Putting the comparison into one table as shown above, it is clearly compared how the condition of NG at diameter lever before improvement and after improvement. Small diameter lever has become the most “no problem” type of NG in comparison with burry, sweling, blackspot, and deform.

Putting the comparison into histogram, it is also clear that the project has successfully reduce the NG bracket form the beginning NG bracket quantity of 13,521 pcs to 6,213 pcs only. This the the acheivement of reducing 54.01% amount of NG bracket flowing to machining process.

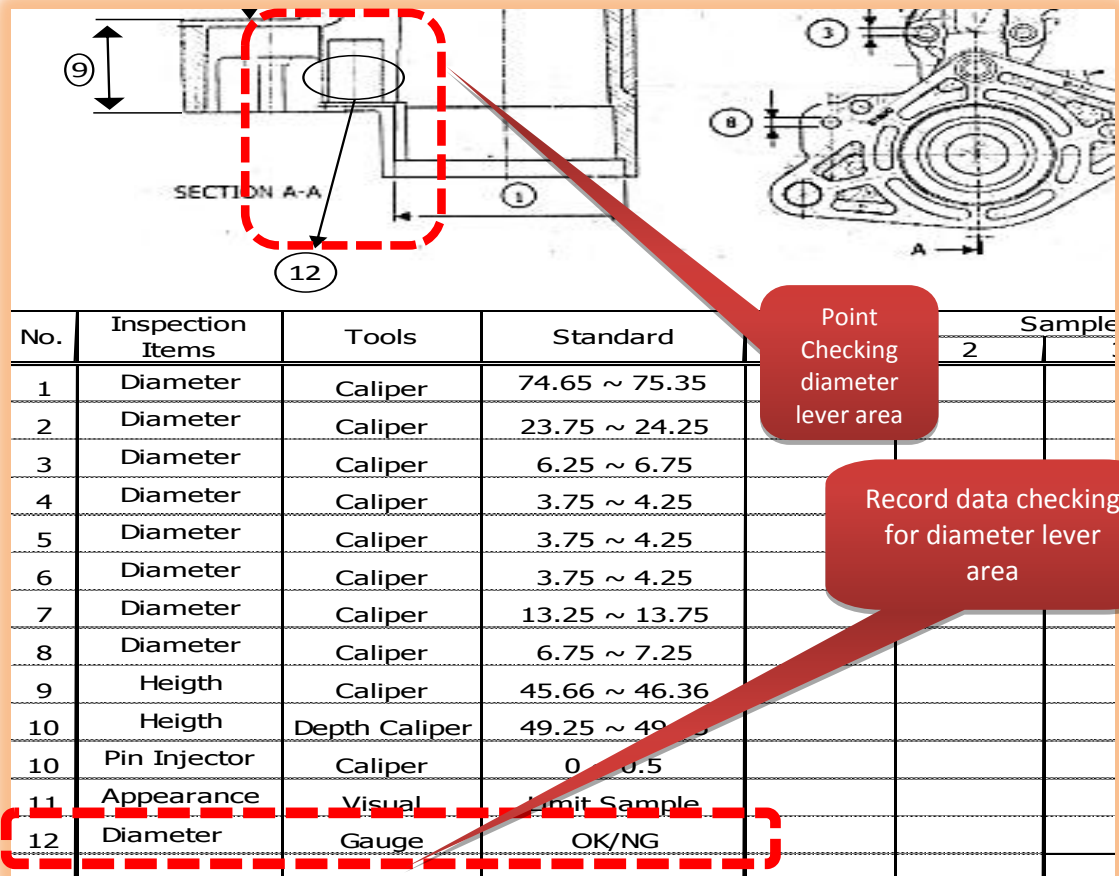
Figure 5.17 Check Sheet Content after Improvement

As the purpose of standardization to apply this improvement continuously, it is expected that by revising the check sheet the quality incoming inspector can from right now start to utilize the revised check sheet which has point check for diameter lever. By applying this standardization, it surely is expected that the NG bracket of small diameter lever will again not flow to machining process and it is really expected that the NG bracket can maximally be minimized after machining process whether it is sent to customer or assembly process at PT. Mitsubishi Electric Automotive Indonesia itself.

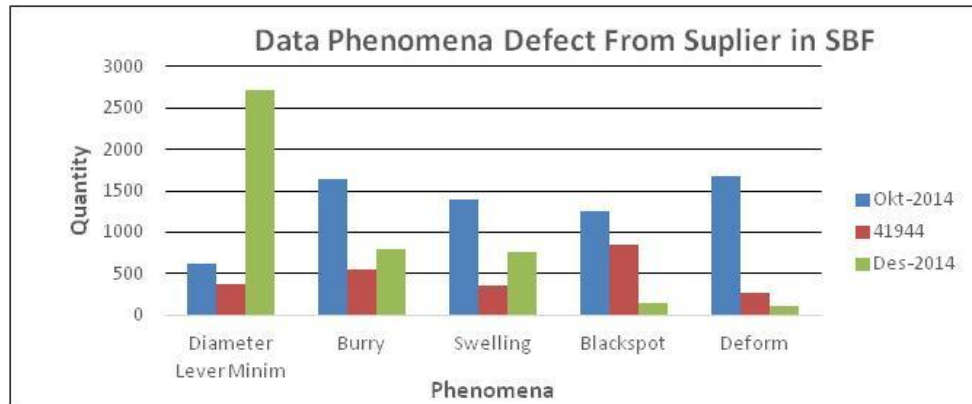
Figure 6.1 NG Phenomena at SBF Line

To realize the improvement continuity leading to minimizing NG product and approaching zero defect action, the next NG type that is mostly existed based on the histogram can next be improved.
